AgustaWestland Products

SERVICE BULLETIN

_№ 189-237

ATA 64 - TAIL ROTOR FLIGHT CONTROL IMPROVED PERIODICAL INSPECTION

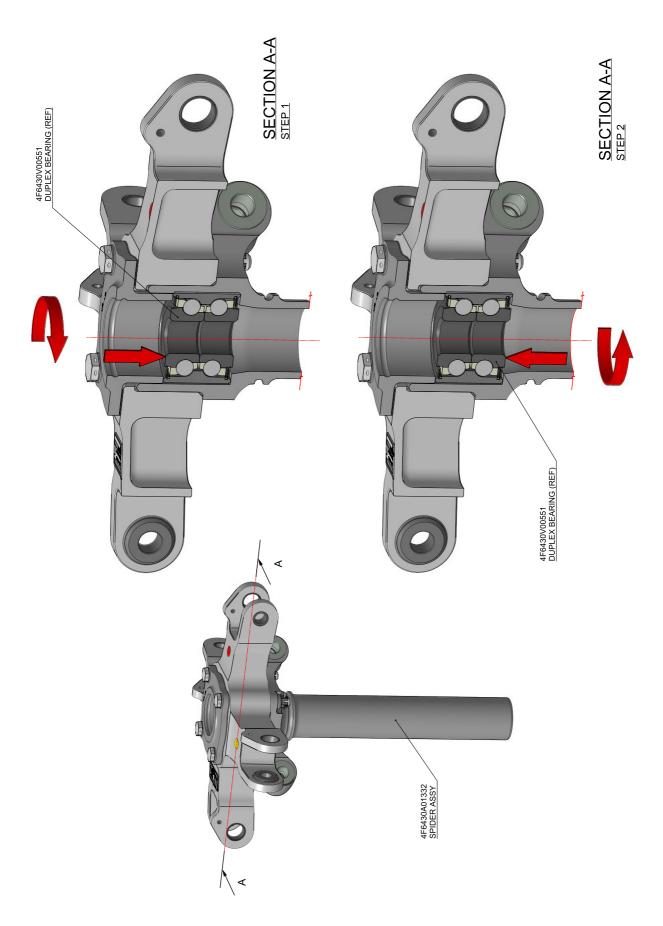
- 5.2 With reference to Figure 6 section A-A Step 1, push the top inner race down and at the same time turn it to feel if there is roughness.
- 5.3 Put your finger into the duplex bearing until you can pull up the lower face of the inner race.

- 5.4 With reference to Figure 6 section A-A Step 2, pull the bottom inner race in the up direction and at the same time turn it to feel if there is roughness.
- 5.5 Repeat the Step 5.1 thru Step 5.4 at least one time to confirm the results.
- 5.6 Record the results of the previous steps on Table V (refer to Figure 11).
